Test Report

Product : Differential

Model No : DG72N

1. Test item : Torsion test .

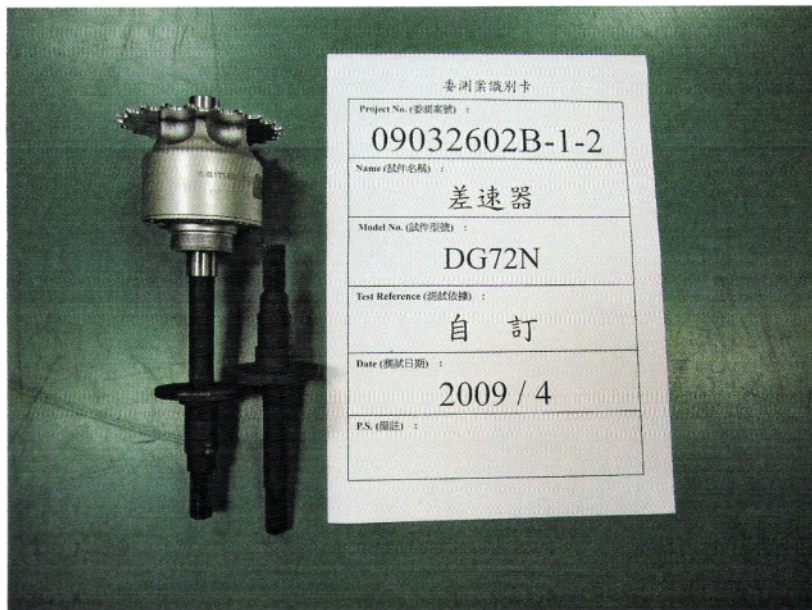
5.1 Test Sample : As shown in Fig. 1 .

Fig. 1 Test Sample

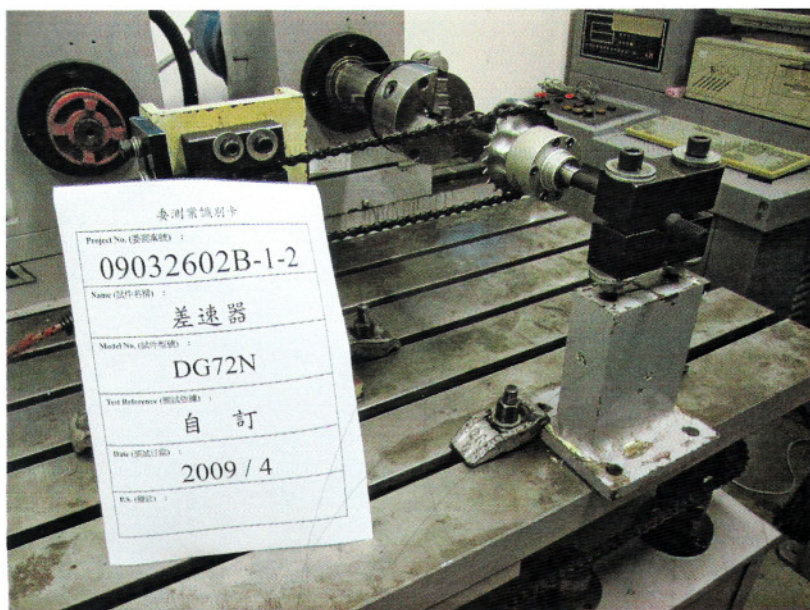
Torsion of the driveshaft reach 1129.54 kg-cm, its angle is 37.8°. After the test, the differential device has not damage on the test situation. Test procedure as shown in Figure 2.

Fig. 2 Torsion test
