Test Report

Product : Differential

Model No : ETG

1. Test item : Torsion test .

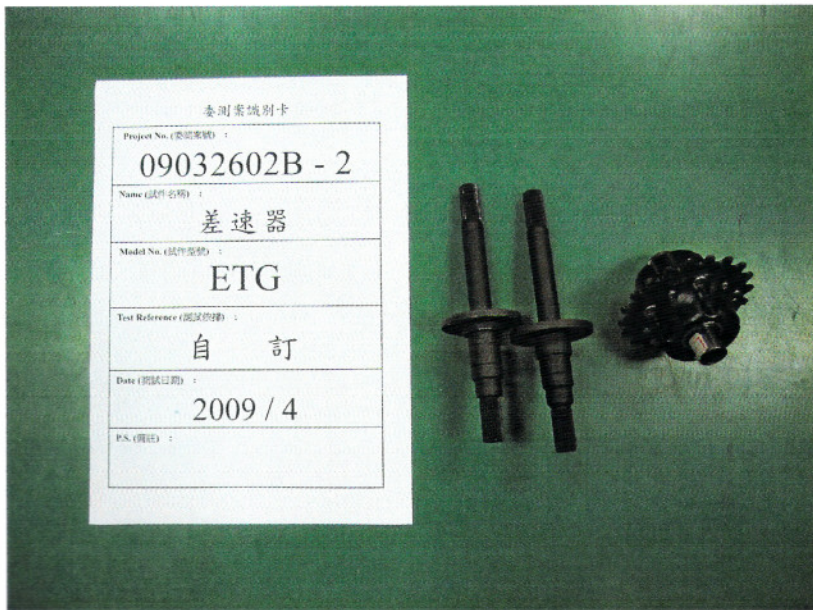
Fig. 1 Test Sample

5.1 Test Sample : As shown in Fig. 1 .

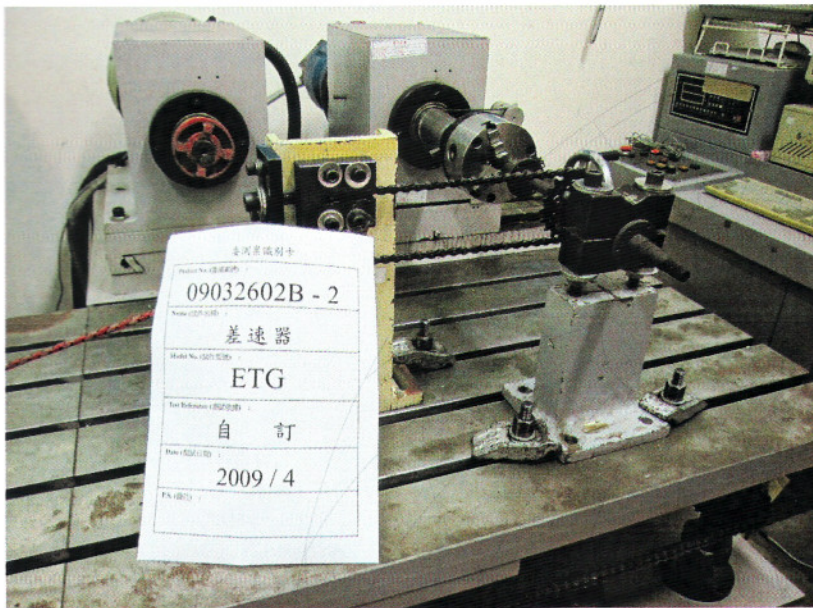
Fig. 2 Torsion test

Torsion of the driveshaft reach 1123.42 kg-cm, its angle is 18.2°. After the test, the differential device has not damage on the test situation. Test procedure as shown in Figure 2.
